Navajo Abandoned Uranium Mine

Site Screen Report

Elwood Thompson No. 1 AUM Site

January 2011

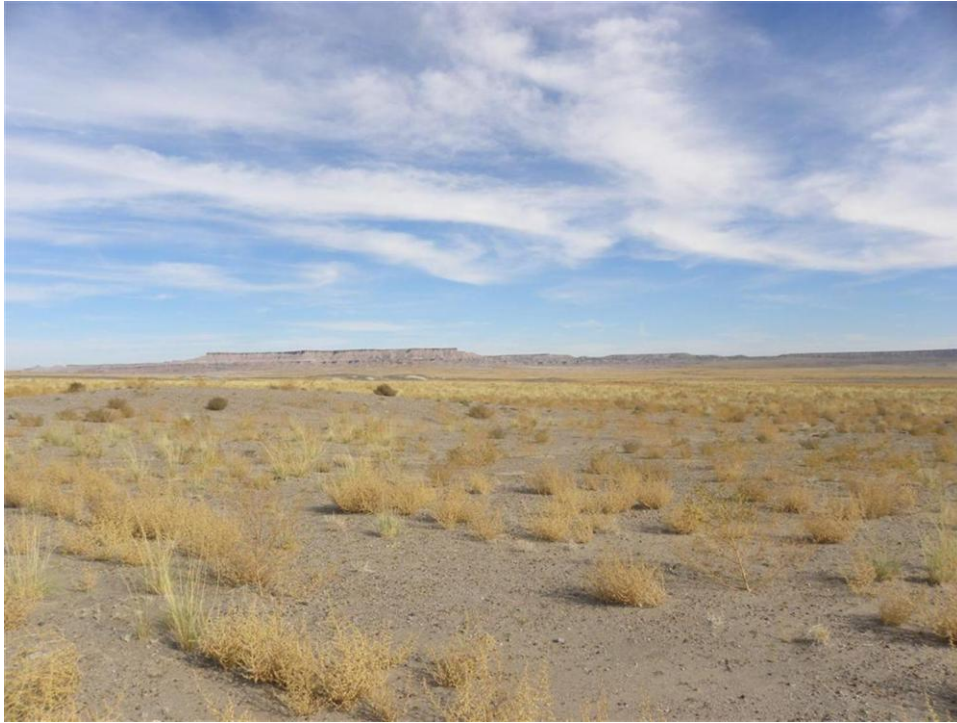
Photo 1. Elwood Thompson No. 1 mine site

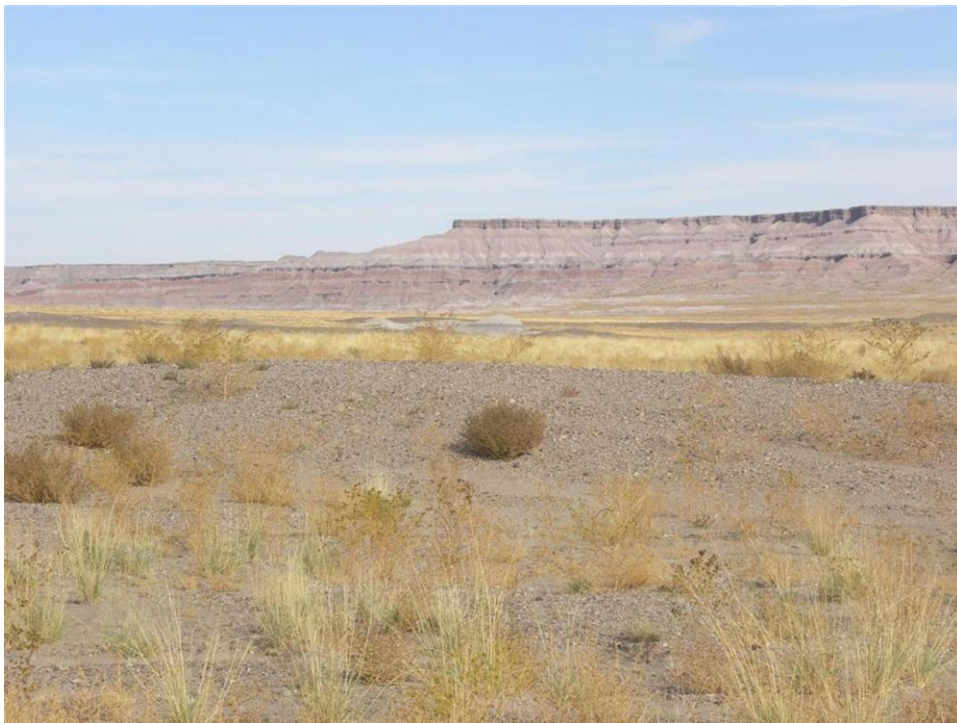
Possible small reclamation cap in center of site, grey material, 75' x 40'

Photo 2. Elwood Thompson No. 1 mine site, reclamation cap

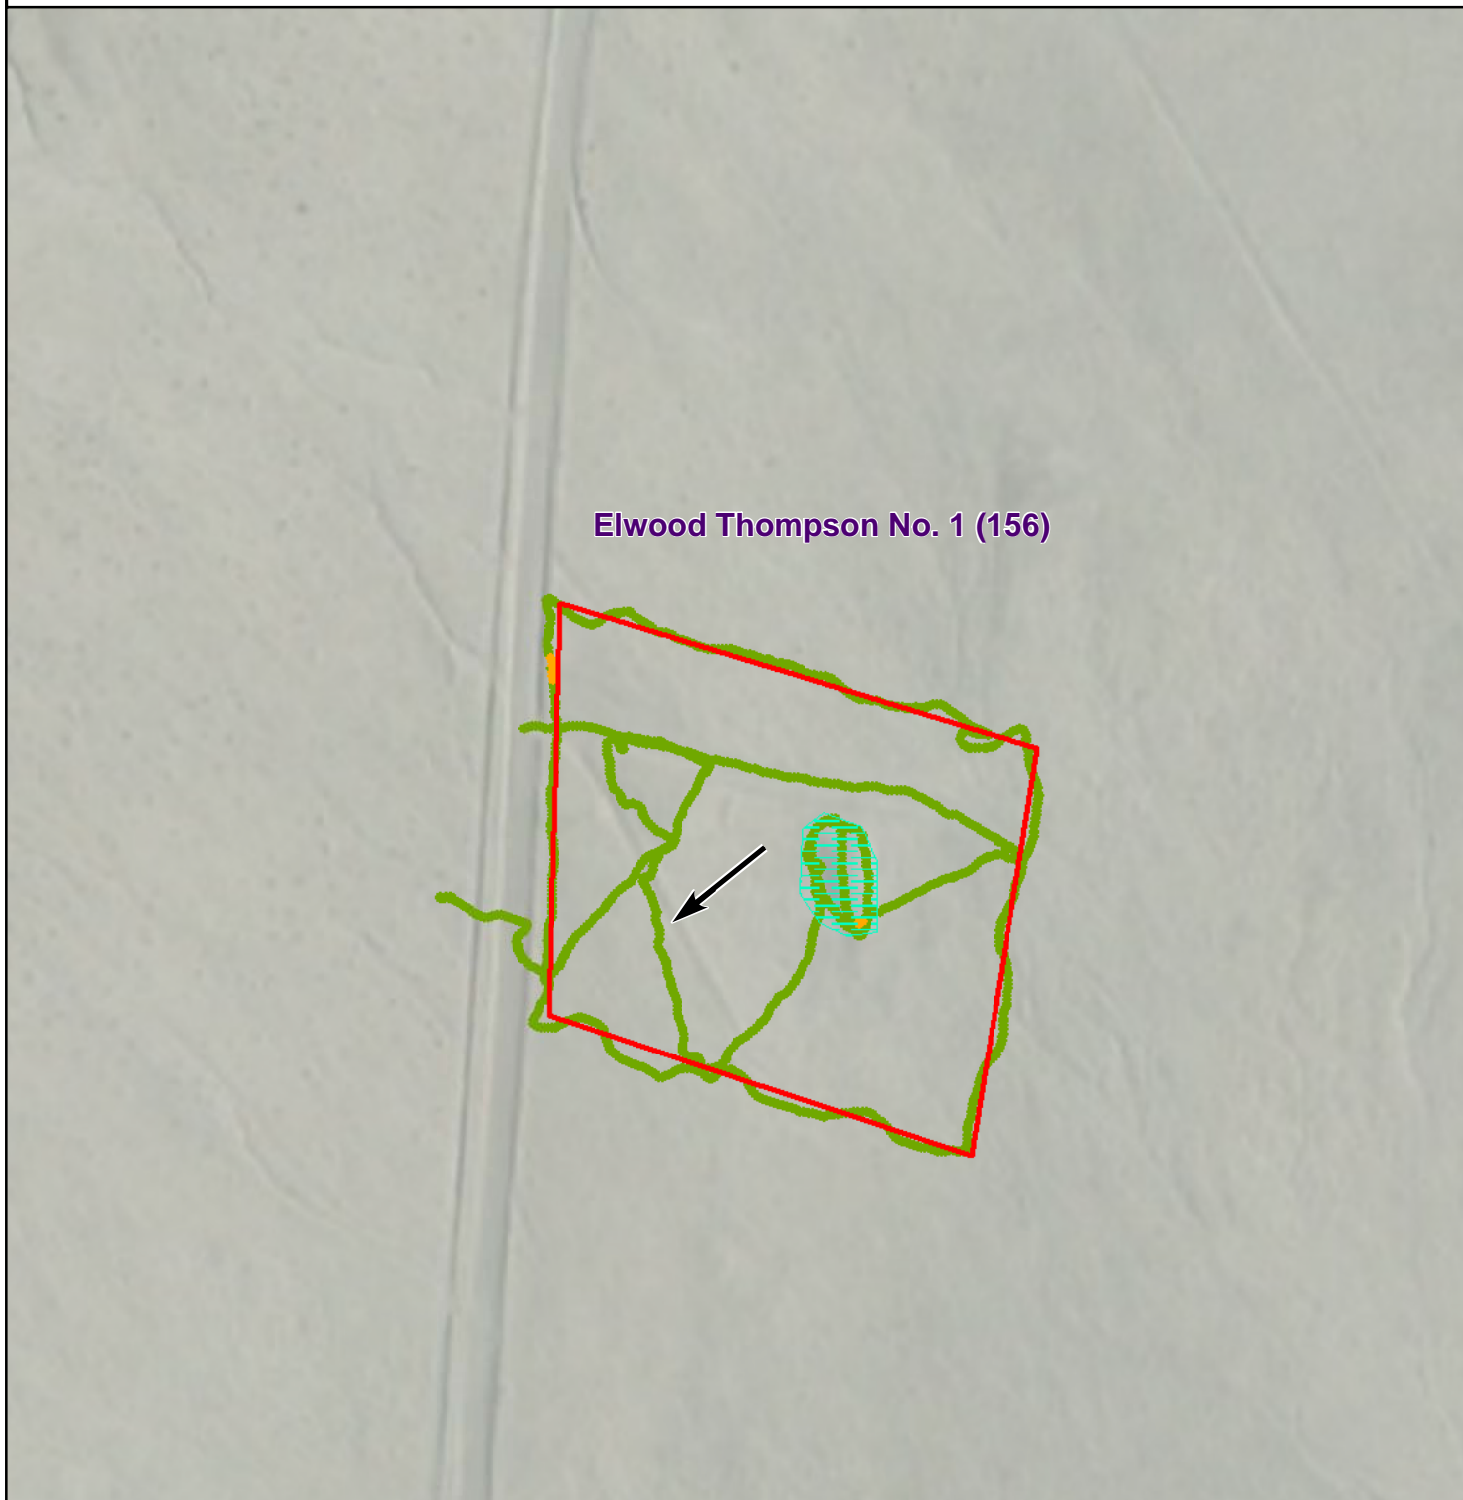
A total of 1,306 gamma radiation measurements were collected from the mine site, ranging from 9,058 cpm to 24,258 cpm. The measurements collected at the reclamation cap were found at a maximum level of approximately 25,000 cpm. The measurements are represented in Figures 1 and 2.

**Figure 1 - Gamma Radiation Measurements, Above Two Times Background
Elwood Thompson No. 1 (156)
Coalmine Mesa Chapter, Navajo Nation**

Gamma survey conducted 11/2010
Measured as counts per minute (cpm)

Average background 9,775 cpm

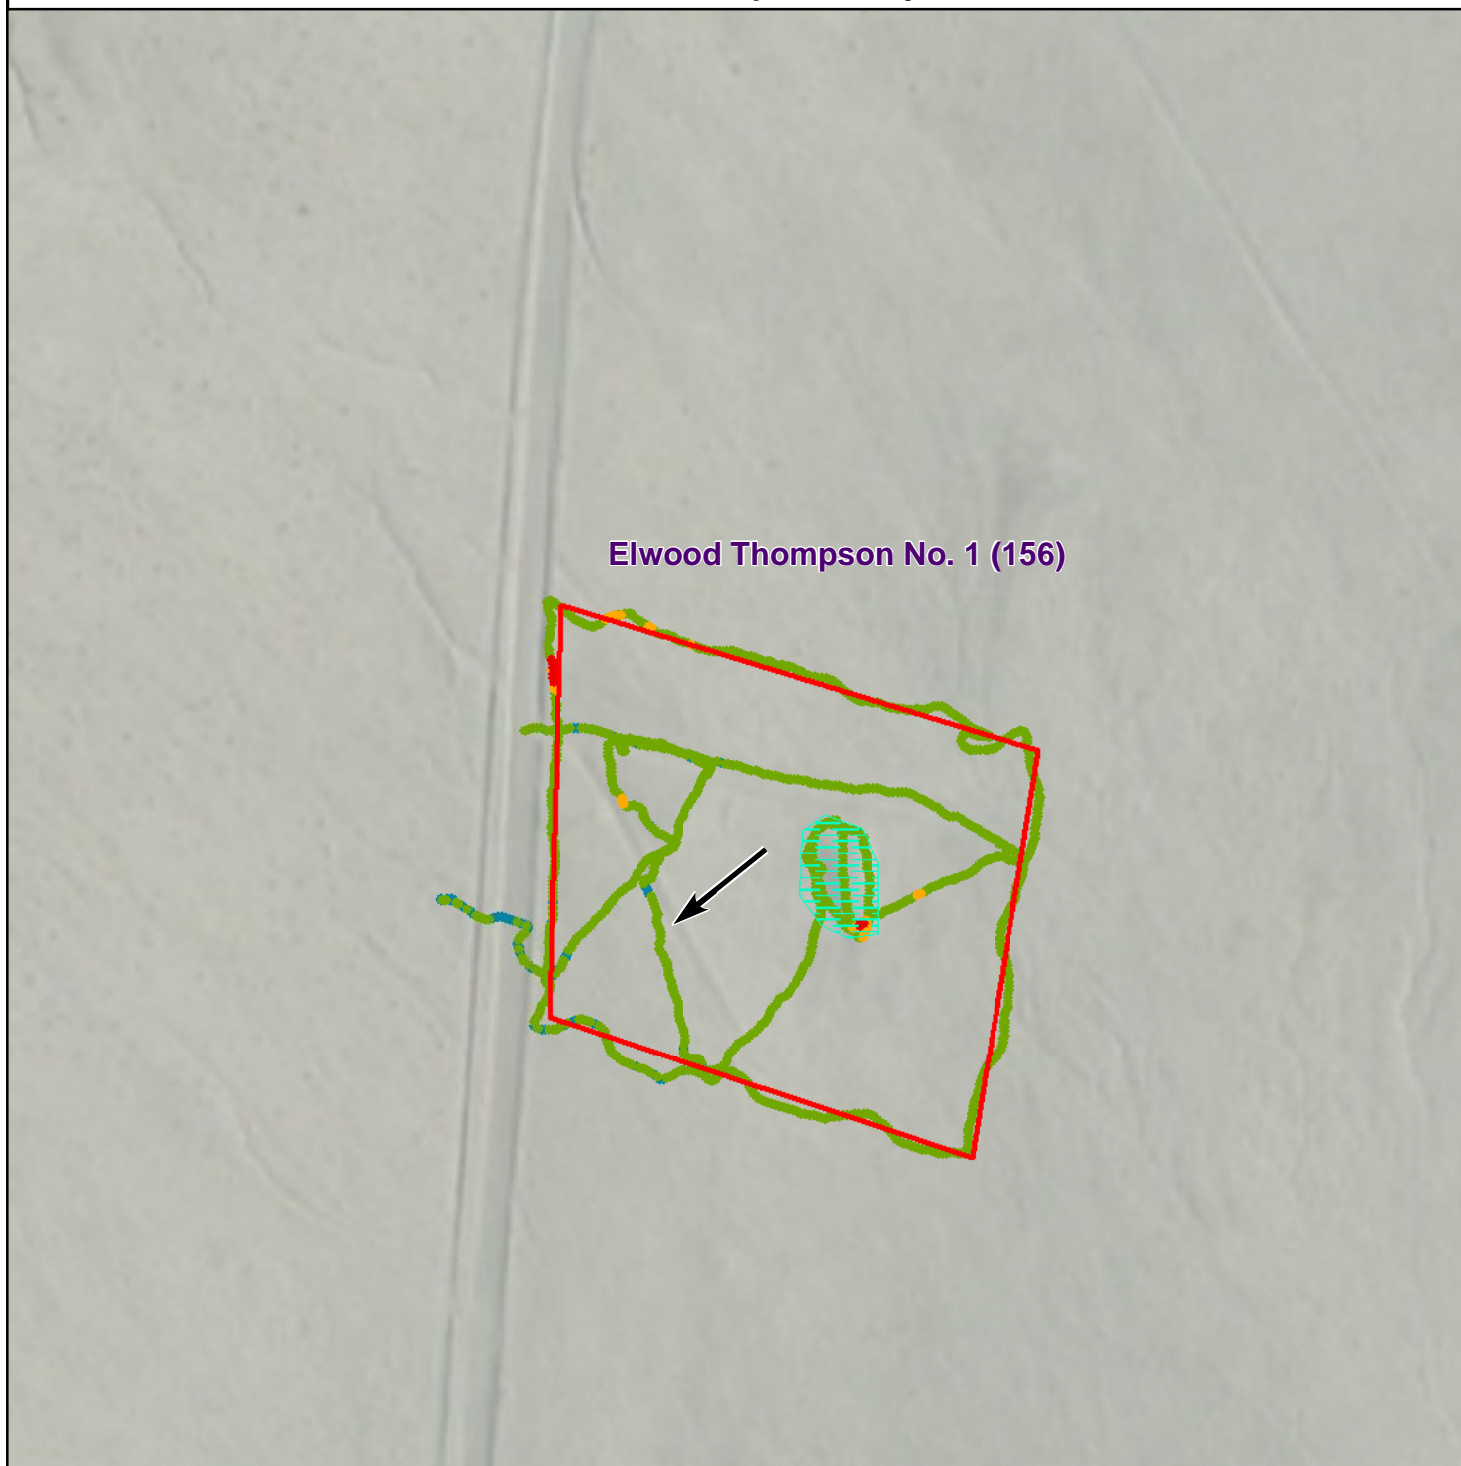
Figure 2 - Gamma Radiation Measurements
Elwood Thompson No. 1 (156)
Coalmine Mesa Chapter, Navajo Nation

Gamma survey conducted 11/2010
Measured as counts per minute (cpm)

Average background 9,775 cpm
